Studies of cultural heritage sites of federal significance

This article is supposed to make a professional analysis and assess the reliability of the historical buildings in Ryazan - an object of cultural heritage of federal importance "House of Saltykov-Shchedrin (Morozov) - 18th century". On the basis of visual inspection and a large number of field studies using methods of ground-based laser scanning, photogrammetric method and other measuring instruments, areas of destruction and loss of the building were identified. According to the results of the analysis of archival documents and the processing of field work, a complex of architectural and archaeological measurement drawings was drawn up, on the basis of which further house restoration will be carried out without any damage to historical material. The article on a specific example provides brief archival information about the historical significance of the building, describes the methods and methods of the survey.

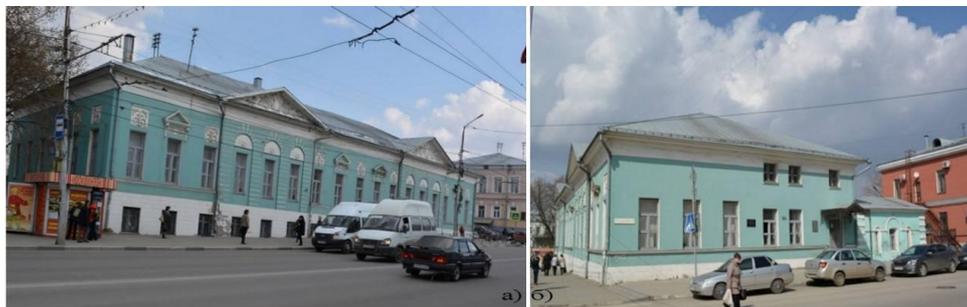
Fig. 3. House Saltykov - Shchedrin (Morozov): a - the main facade on Lenin Street (Astrakhanskaya); b - side facade on Nikolodvoryanskaya street, photo 2016

especially on treads. The main entrance to the building (porch) - with white-stone steps under the metal canopy is located at the side facade on Nikolodvoryanskaya Street (Fig. 3. b). The porch has three sides. The condition of the porch is unsatisfactory: the steps have cracks, chips and material loss.

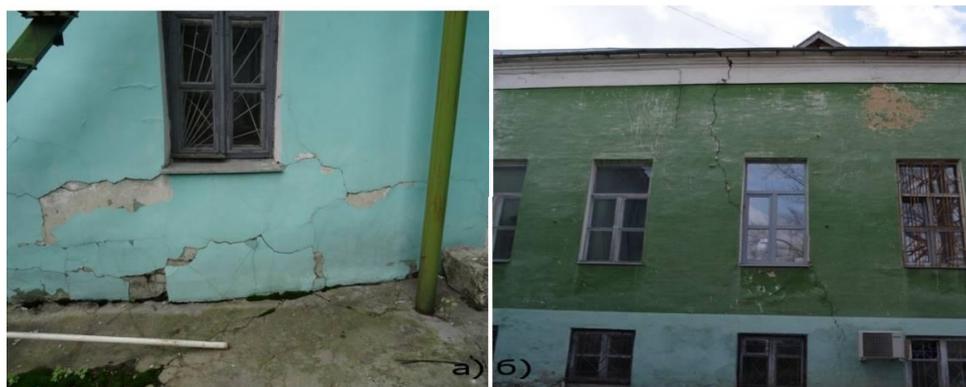
- Cracks on the outer facade opening up to 0.3 mm.
- Cracks on the outer wall of the courtyard facade opening up to 5 mm at the junction of the later extension (Fig. 4.b).
- Traces of soaking on the yard facade and green algae on the concrete pavement (Fig. 4.a).

Fig.4. The courtyard facade: a - condition of the lower part of the wall of the extension of the end of the 19th century;  
b - through vertical crack in the northern part of the building

The walls are plastered with painting. Plaster walls have cracks opening from hair to 2 mm. On the surface of the walls in their lower part, there are traces of moisture damage: numerous cracks in the plaster, loss of the paint layer, in a couple of places - the loss of the plaster layer. The base also has many cracks in the plaster layer opening up to 5 mm. (Fig. 4a, b).

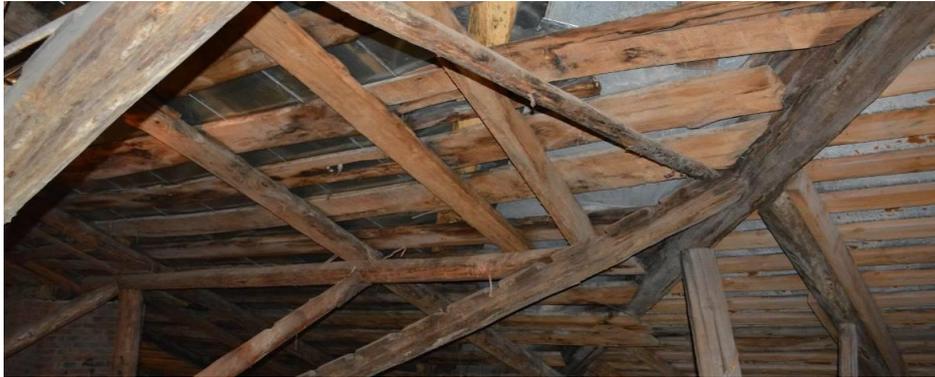
The roof is metal of roofing tin, hip. The roof has leaks, the joints in the sheets are loose, and there are holes. Minor traces of decay due to leaks in the roof.

The condition of the supporting structures of the roof, truss legs is operational; the condition of the roofing and lathing is unsatisfactory (Fig. 5).

Fig. 5. Attic. The state of the truss system and roof  
**Analysis. Preliminary engineering opinion.**

The roof is made of galvanized steel, ordinary, and the bottom has been significantly rusty, which indicates the formation of condensate due to deficiencies in the temperature and humidity conditions of the attic room. There is an organized drainage system, which is in an unsatisfactory state: its individual elements are lost or deformed, the pipe marks abut against the ground, which is wrong.

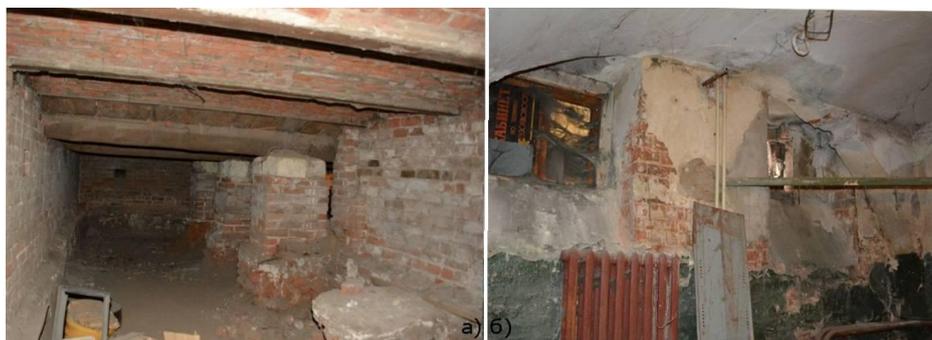
The floors are flat, presumably wooden. Finishing surfaces of floors - plaster and paint. Only the basement floor of the historic part of the building is covered with box-shaped vaults (Fig. 6.b) and Monier brickeds (Fig. 6.a).

The state of the floors is unsatisfactory - there is a partial loss of the paint layer and plaster layer in several places.

Fig. 6. Basement floor: a - basement floor (1804). Monier vaults; b - basement of the historic part of the building
